111 New Home Way

Property Inspection Report

PROPERTY INSPECTION REPORT

By: Frank Schulte-Ladbeck TREC# 9073 11/11/2011
(Name and License Number of Inspector) (Date)

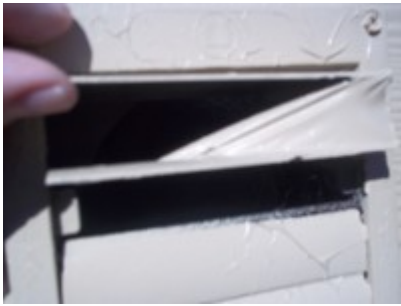
Vent for Master bathroom on right side was painted over in such a way that the louvers were stuck together. The range hood vent was not well painted on the left side of the home, with some spots near it.

Vent painted over, sealing louvers.

On 12/5: the vents had been cleaned to allow free movement. There is still a bit of touch up needed on the left side clapboard by vent.

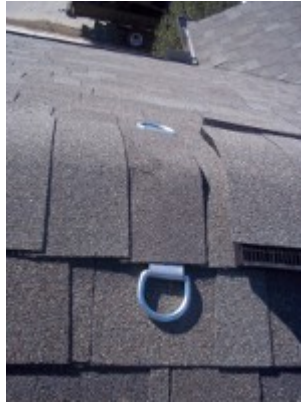
A hook system for working on the roof was left in place on the top ridge.

On 12/5: the hook system appears to be in place still. There is a chance that this could lead to damage. The roof and the flashing over the front porch was addressed.

Hook in top roof ridge.

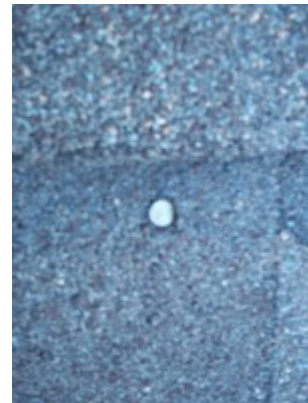
There was an exposed nail that should be caulked below the vent on the roof for the dryer.

Exposed nail below dryer vent.

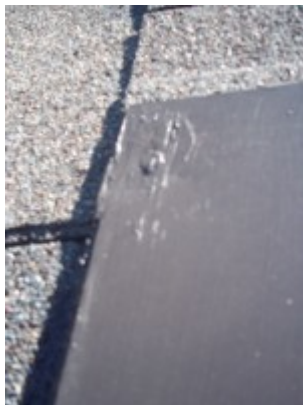
The flashing under the windows of the left front bedroom needs to be repainted.
. The flashing on the chimney needs better caulk on the nail head.

Nail has caulk, but could be better-chimney flashing.

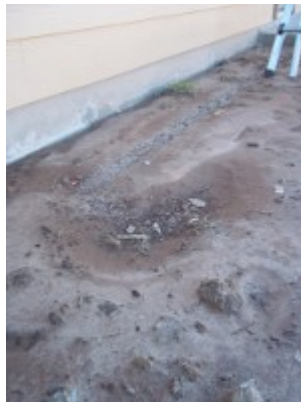
The grading in the rear had the basic grading to divert water to the middle of the yard, and then down to the street. However, this grading was not ready for grass it seemed. Also, the water was still standing on the right side of the home from rain two days ago. The grading allows for water to pool near the Master bedroom bay windows near the rear porch.

On 12/5: some corrections to the grading in the rear were made. There is still a concern with the grading near the Master bed.

Grading allows pooling near Master bedroom and right side of home.

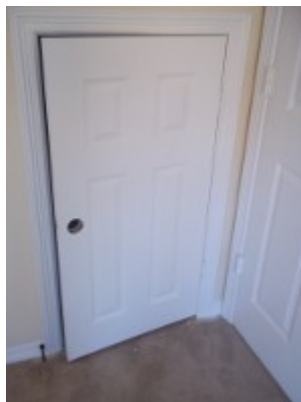
Master bedroom closet under the stairs did not have a door handle or a door stop.

On 12/5: garage door was operable. Door stop was added for Master bedroom, but no handle.

Door without handle and stop in Master bed.

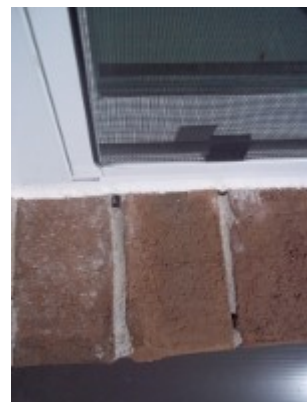
The brick sill in the window above the front entry, second story, had gaps in the mortar that need to be filled to prevent moisture entry.

Gap in brick sill mortar over porch

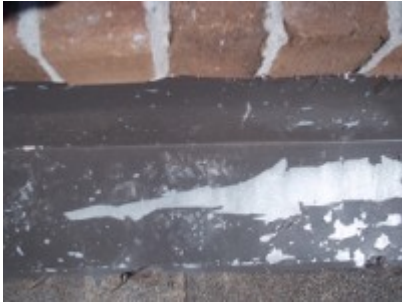
Flashing over porch in need of paint.

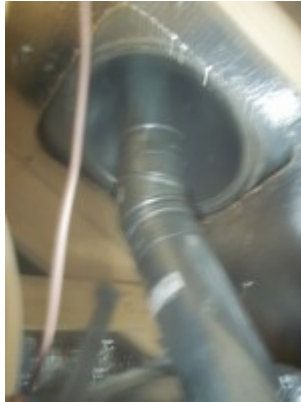
Heater furnace needs to be strapped in.

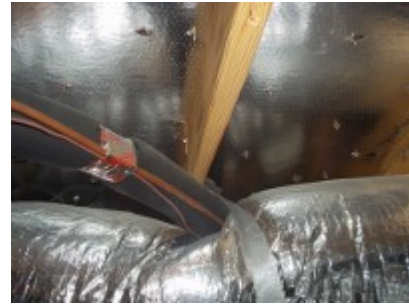
Hot refrigerant line touching duct.

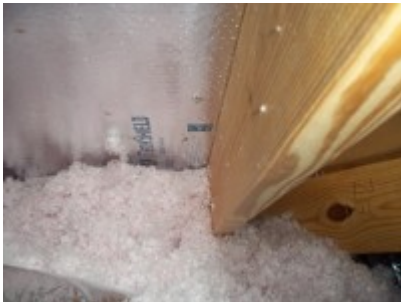
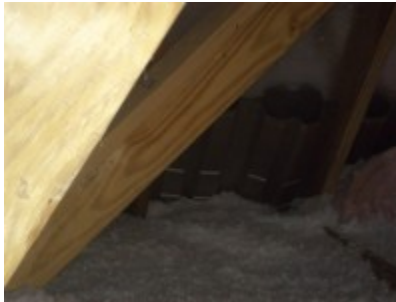
Condition/Description: radiant barrier on the sheathing (this helps with energy efficiency. Attic was framed with rafters, joists, and braces in a proper way. Baffles were in place to allow air movement under the sheathing, but there were a few places where insulation blocked the air flow.

Insulation blocking air movement, but most spaces ave baffle as seen in picture on the right.

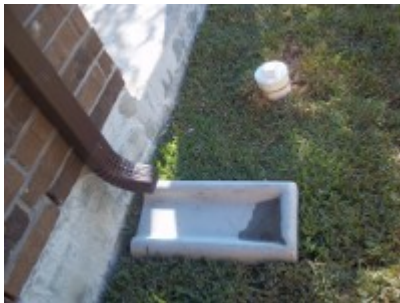
Condition of the gutter system: on the front of the home. The splashguards are turned around the wrong way. They currently hold water, where they should be directing water away from the home.

Splashguards turned around wrong, so they will hold water.
