111 Town Home Court

Property Inspection Report

Concerning: 111Town Home Court
(Address or Other Identification of Inspected Property)

By: Frank Schulte-Ladbeck TREC# 9073 11/11/2011
(Name and License Number of Inspector) (Date)

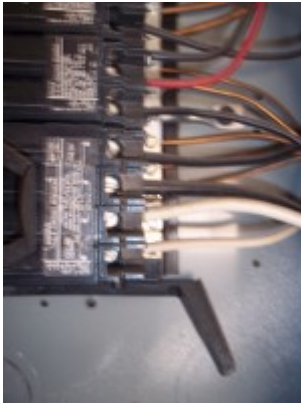
There are two breakers marked for 40amp service which appear to be attached to wires that are for 30amp service. Everything was working, but this situation may cause problems in the future. For this reason, and coupled with some findings in the section below, I would suggest having a qualified electrician examine this system.

Bottom right of panel has wiring or breaker .which are improperly sized.

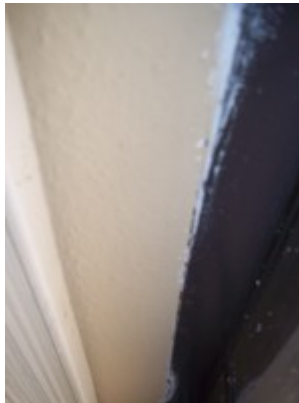
Wall joints where the wall meets a door or window or where the expansion joint is do need new caulk on the exterior. There is also the joint at the top of the window frame and interior wall which needs to be sealed.

Gap in window frame needs sealing

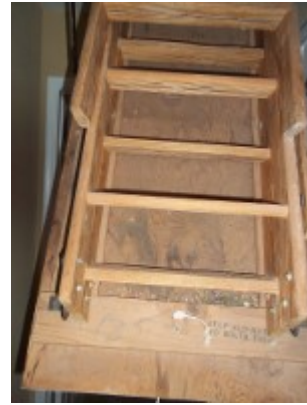
Attic Entry: in the ceiling of upstairs hall. This does have some damage to the edge, and there is no weatherstripping or insulation on the door. This allows heat to transfer to the living space below. The door is mainly attached with screws. These should be nails (screws can break when lateral forces are applied, which happens when climbing the ladder.

No insulation on door

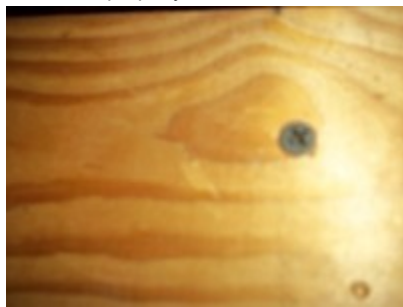
Screw not proper for attic ladder.

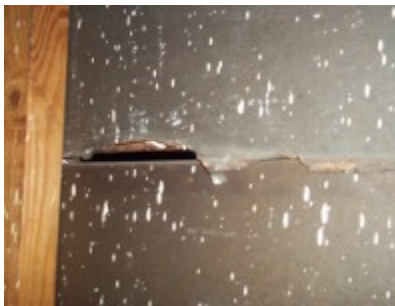
Condition/Description: the framing is a truss system. There are walk way areas in the attic, but not a continuous walk from the entry landing to the equipment., which can hinder technicians working on the equipment.
There is a firewall between the units; however, this wall is damaged.

Example of gap in firewall between units.

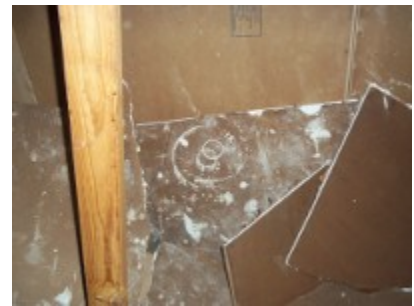
Material left on insulation

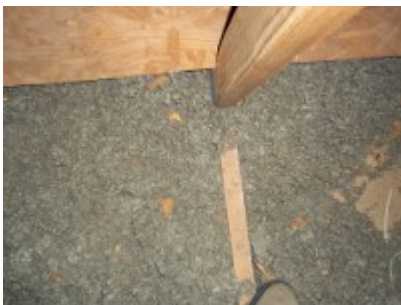
Approximate Average Depth of Insulation: 6"
joists (framing for the ceiling) were not covered by insulation, which allows heat to transfer down to living space. Also, no items should be on the insulation; compacting insulation reduces its effectiveness, and this was the case here with some items near the entrance, but also boards on the other side of the skylight.

Insufficient insulation, not covering joist.

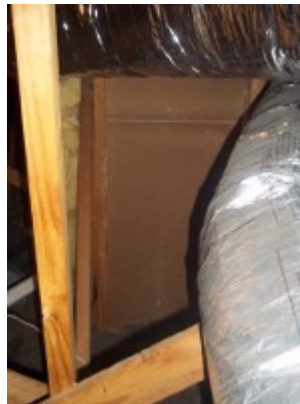
Approximate Average Thickness of Vertical Insulation: 8"
not all spaces that required insulation on the skylight where covered.
(As with the above, each insulation is different; however, having at least 10" of insulation is the best for energy efficiency.)

Missing insulation from skylight.

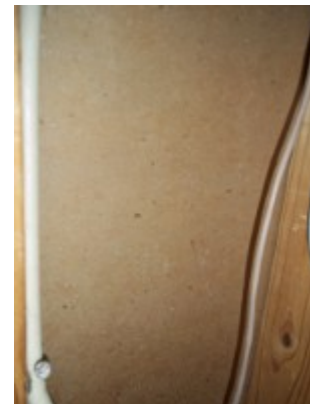
There is wiring in the return chase, which is now seen as a hazard, although this had been a common practice. The return chase is not sealed. Not as important since the chase is on the interior of the unit, but sealing it would block the wires, and help to improve efficiency.

Wiring in return chase.

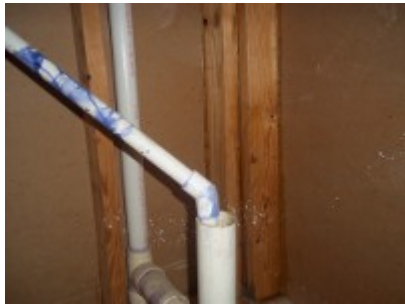
Unsealed return chase. Plumbing in chase is the primary drain for evaporator coil.

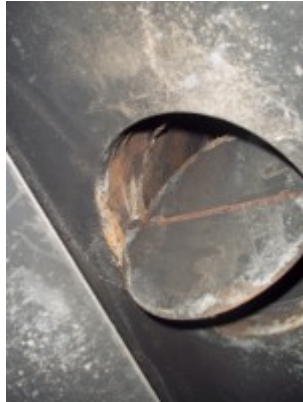
The downstairs firebox had a damper that would not fully close, which can effect energy efficiency. This was due to part of the flue sheeting in the way. The downstairs flue had creosote, which needs to be cleaned. The upstairs damper did close, and there was no creosote build-up.

Damper will not close due to metal of flue.

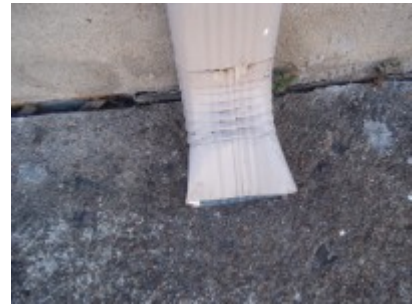
Condition of the gutter system: gutter in rear of home is bent at the downspout, which could lead to debris in gutter clogging the downspout. One front downspout has a tube on it to direct water away, but the other downspout does not. Water may pool on the porch.

Damaged downspout rear.

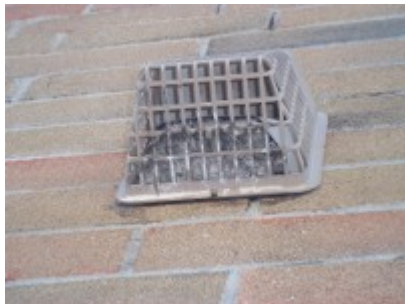
Lint in dryer vent line clogging the exhaust point.

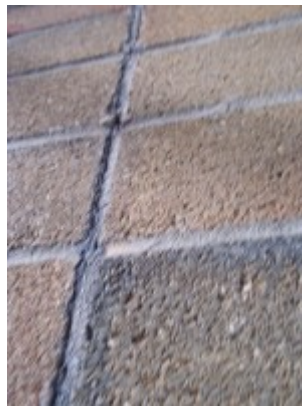
Expansion joint beginning to need new caulking.

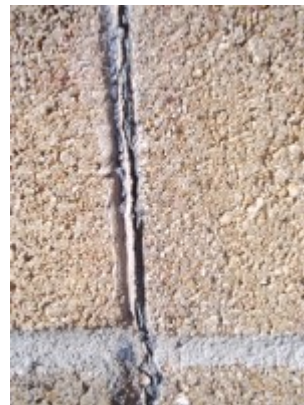
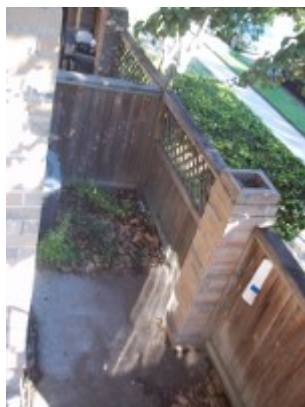
Condition of the grading of the land: the front porch appears to hold water; however, if the leaves are cleared from around the air conditioning unit, water may flow away from the porch. If not, some regrading would help water to flow away.

Overview of front porch. Water may pond at the far end due to leaves on the ground.
